## Important Medical Device advisory - Update

### HeartMate 3™ Left Ventricular Assist System Catalog # 106524INT – HM3 LVAS KIT

May 28, 2018

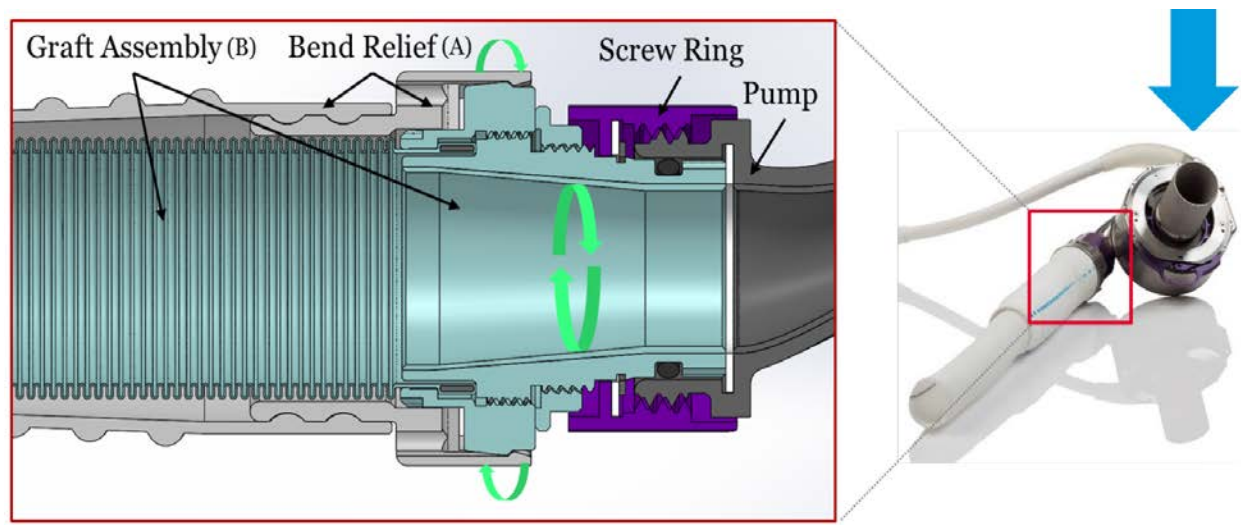
The HM3 is designed to allow for Outflow Graft connector rotation by the surgeon after connection to the pump, so that proper alignment of the Outflow Graft can be made during implantation without disconnecting the Outflow Graft connector from the pump. Appropriate tightening of the Screw Ring (see below) during implantation reduces, but does not eliminate, the propensity of the Outflow Graft connector to rotate. *In vivo*, normal forces can rotate the metallic Outflow Graft connector; if the rotation is in one direction only (instead of back-and-forth (clockwise/counter-clockwise)), then twist will accumulate in the graft. Accumulation of Outflow Graft twist can occur at any time point post-implantation. The twist may deform the Outflow Graft (a twist occlusion) and reduce or stop pump flow. The time course from the beginning of an accumulation of twist to an occlusion is unknown and may be variable among patients. Occlusion of the HM3 Outflow Graft often requires urgent surgical intervention.

During implant, when attaching the Outflow Graft to the Pump Cover, a clicking sound will be heard as the Screw Ring is tightened. Continue turning the Screw Ring clockwise until it comes to a complete stop and stops clicking. Firmly hand-tightening the Screw Ring may reduce the risk of Outflow Graft twisting by increasing the resistance to metallic Outflow Graft connector rotation. To avoid damaging the Outflow Graft assembly, do not use tools to tighten the screw ring. This updated information (see Appendix 1) will be incorporated into the Instructions for Use following regulatory approval in each geography.

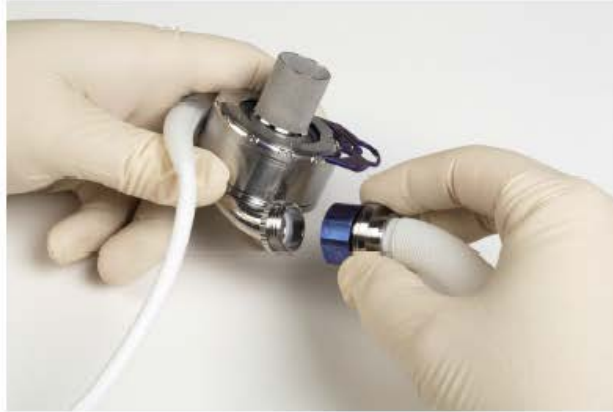
Figure 5.34 Attach the Graft

- Twisting of the Outflow Graft has been identified in some patients post-operatively. Occurrences of twisting have resulted in graft occlusion, thrombosis, and/or death. The accumulation of twist within the graft is related to rotation of the metallic Outflow Graft connector within the attached Outflow Graft Bend Relief connector.

1. Remove the thread protector from the Pump and the Outflow Graft. Using the Screw Ring, attach the Outflow Graft to the Pump Cover, turning the ring clockwise. You will hear a clicking sound as you tighten the Screw Ring (this is normal). Continue turning the ring clockwise until it comes to a complete stop and stops clicking. See **Figure 5.34**.

Firmly hand-tighten the Screw Ring to ensure sufficient resistance to Outflow Graft twisting. To avoid damaging the assembly, do not use tools to tighten the Screw Ring.

2. Verify that the graft is not twisted or kinked by checking the position of the black line on the graft above and below the bend relief. The line should be straight.
