## URGENT MEDICAL DEVICE CORRECTION

CentriMag™ Acute Circulatory Support System Motor Model: 102956  
*Compatible with CentriMag™ Pump and PediMag™ Pump*

September 5, 2018

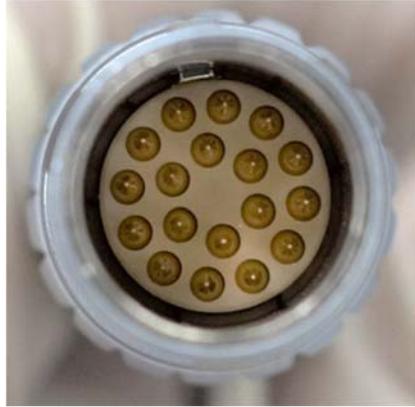
**Figure 2: Motor Connector Pin View**

- Visual inspection regarding inspection for motor cable damage from the CentriMag Circulatory Support System Operating Manual and supplemental pages (for 1<sup>st</sup> Generation Consoles)
1. Visually inspect the CentriMag Motor connector for bent or broken pins. Check for burn marks or melted plastic.

Note: If there are any issues while connecting the CentriMag Motor to the CentriMag Console, inspect the Motor port on the rear of the Console for damage, particularly for any broken pins that may be lodged inside.

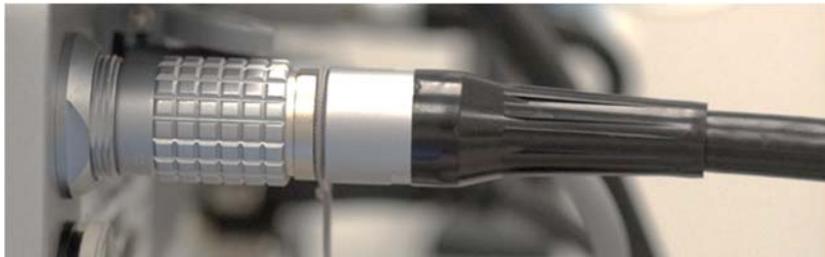
**Figure 3: Cable Bend Relief at the Console Connector**

2. Visually inspect the entire length of the CentriMag Motor cable, including both bend reliefs (see Figures 3 and 4), for any damage such as separations of the bend reliefs, deformations, kinks, or cuts. These types of damage indicate wear and tear or previous rough handling of the cable, which has the potential to result in internal wire damage. Cable thickness and shape should be uniform throughout the length of the cable.

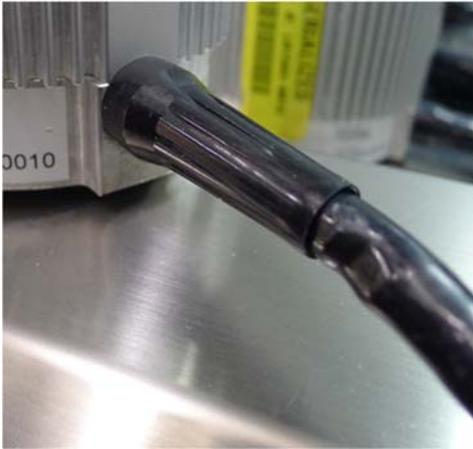
Our analysis of devices associated with the motor stop field complaints showed that the motor stop can be attributed to a break of a wire or short circuit between wires within the electrical cable where the cable exits the motor cable bend protection. This damage may be avoided by ensuring proper handling, such as avoiding tight bending of the cable, or winding the cable around the motor during storage during the life of the motor.

**Figure 5: Cable Damage at the Motor Bend Relief**

**Before each use, verify that the cable connecting the Motor to the Console is not kinked, which can occur with improper handling such as wrapping the cable tightly around the Motor. If the cable is kinked, replace the Motor.**

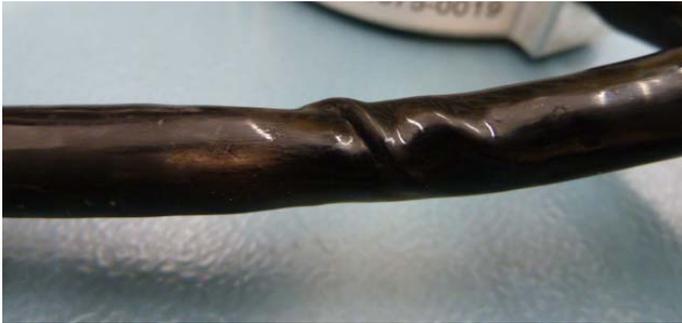
**Figure 7: Damaged Motor Cable**

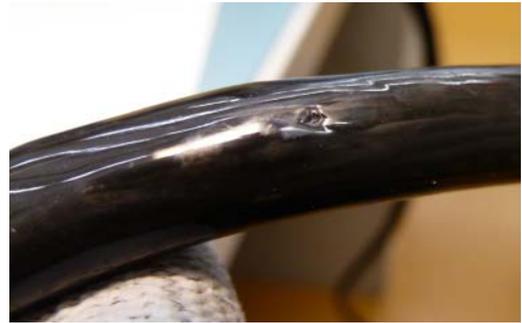
**Figure 8: Damaged Motor Cable**
