IMPORTANT MEDICAL DEVICE ADVISORY

HeartMate 3™ Left Ventricular Assist System Catalog #106524US LVAS KIT, HM3

April 5th, 2018

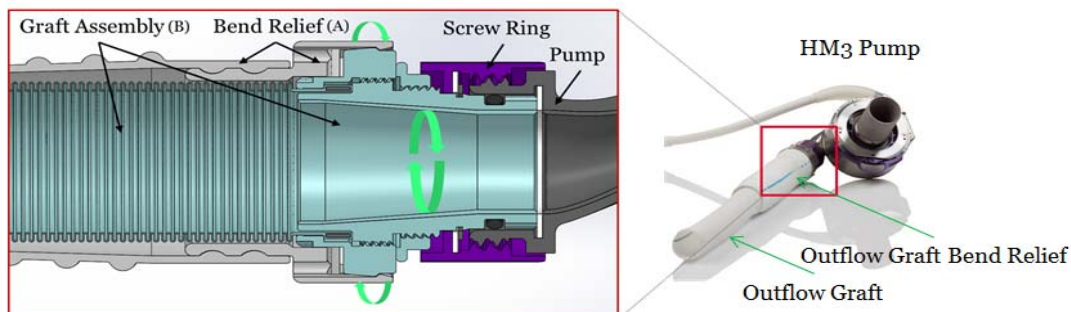
The Outflow Graft is the conduit for blood flow from the HM3 pump to the ascending Aorta.

Normal *in vivo* forces associated with heart beats, respiration and patient activity can cause small rotations between the Outflow Graft Bend Relief (A) and the pump. These rotations are expected and appear to be 'back and forth' without accumulation in either direction. However, there is the potential for these forces to be preferentially translated to the outflow graft (B) in either the 'back' or 'forth' direction which may deform the outflow graft and reduce pump flow. The accumulation of outflow graft twist can occur at any point beyond implant. Postoperative twisting and occlusion of the HM3 outflow graft may result in the need for surgical intervention following the original implant procedure.

- During implant, when attaching the Outflow Graft to the Pump Cover, a clicking sound will be heard as the Screw Ring is tightened. Continue turning the Screw Ring clockwise until it comes to a complete stop and stops clicking for a firm hand tightened connection.
- If a low flow alarm persists at any time following implant, and other potential causes such as hypertension, low preload, right-heart failure and inflow occlusion have been considered for cause, a Computed Tomography (CT) angiography should be taken to identify the possibility of an outflow graft twist occlusion.
- In the event surgical repair of the outflow graft is needed due to a twist occlusion, the Outflow Graft Bend Relief should be reattached in its original state or repaired to prevent further kinking or occlusion of the graft.
