## URGENT MEDICAL DEVICE RECALL

### HeartMate 3™ Left Ventricular Assist System Catalog #106524US LVAS KIT, HM3

May 21, 2018

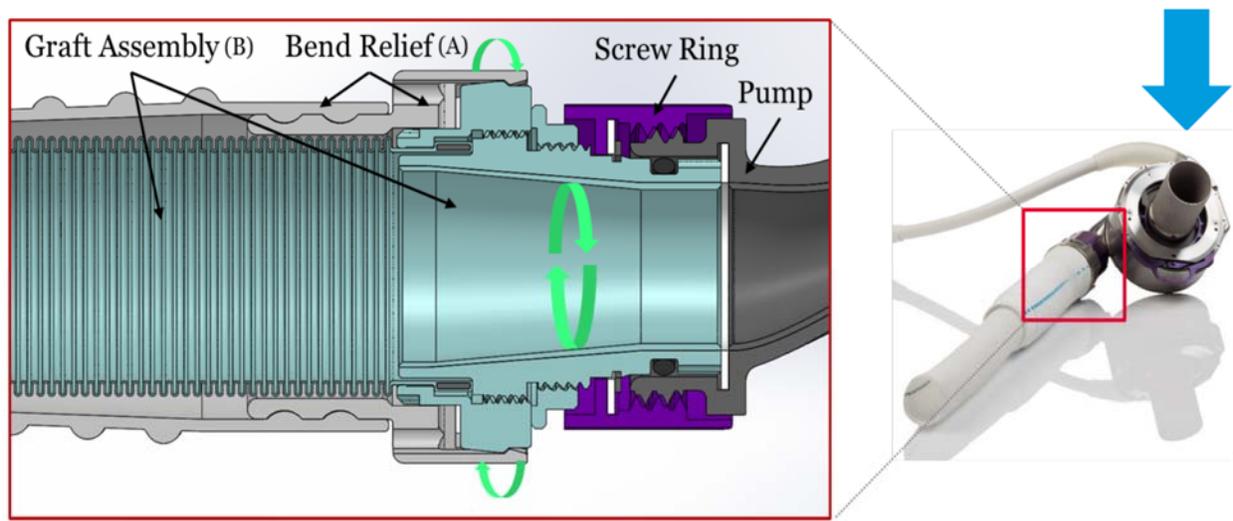
The HM3 is designed to allow for Outflow Graft connector rotation by the surgeon after connection to the pump, so that proper alignment of the Outflow Graft can be made during implantation without disconnecting the Outflow Graft connector from the pump. Appropriate tightening of the Screw Ring (see below) during implantation reduces, but does not eliminate, the propensity of the Outflow Graft connector to rotate. *In vivo*, normal forces can rotate the metallic Outflow Graft connector; if the rotation is in one direction only (instead of back-and-forth (clockwise/counter-clockwise)), then twist will accumulate in the graft. Accumulation of Outflow Graft twist can occur at any time point post-implantation. The twist may deform the Outflow Graft (a twist occlusion) and reduce or stop pump flow. The time course from the beginning of an accumulation of twist to an occlusion is unknown and may be variable among patients. Occlusion of the HM3 Outflow Graft often requires urgent surgical intervention.

During implant, when attaching the Outflow Graft to the Pump Cover, a clicking sound will be heard as the Screw Ring is tightened. Continue turning the Screw Ring clockwise until it comes to a complete stop and stops clicking. Firmly hand-tightening the Screw Ring may reduce the risk of Outflow Graft twisting by increasing the resistance to metallic Outflow Graft connector rotation. To avoid damaging the Outflow Graft assembly, do not use tools to tighten the screw ring. This updated information (see Appendix 1) has been incorporated into the Instructions for Use.

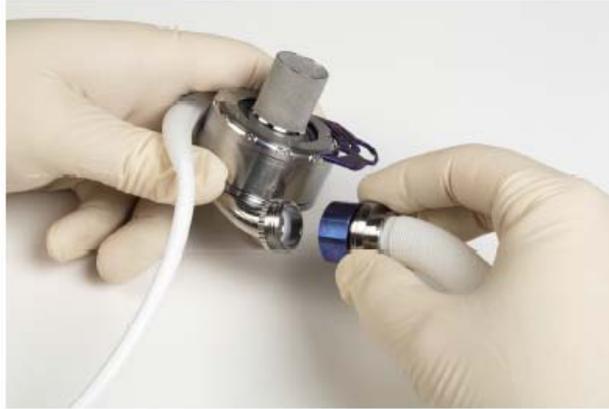
Figure 5.34 Attach the Graft

- Twisting of the Outflow Graft has been identified in some patients post-operatively. Occurrences of twisting have resulted in graft occlusion, thrombosis, and/or death. The accumulation of twist within the graft is related to rotation of the metallic Outflow Graft connector within the attached Outflow Graft Bend Relief connector.

1. Remove the thread protector from the Pump and the Outflow Graft. Using the Screw Ring, attach the Outflow Graft to the Pump Cover, turning the ring clockwise. You will hear a clicking sound as you tighten the Screw Ring (this is normal). Continue turning the ring clockwise until it comes to a complete stop and stops clicking. See **Figure 5.34**.

Firmly hand-tighten the Screw Ring to ensure sufficient resistance to Outflow Graft twisting. To avoid damaging the assembly, do not use tools to tighten the Screw Ring.

2. Verify that the graft is not twisted or kinked by checking the position of the black line on the graft above and below the bend relief. The line should be straight.

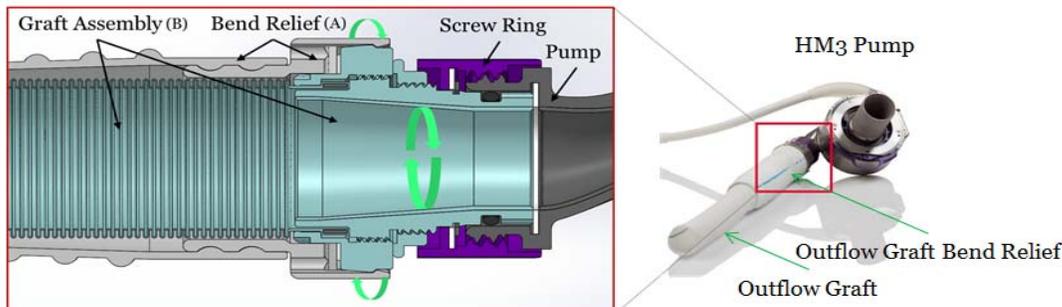
The Outflow Graft is the conduit for blood flow from the HM3 pump to the ascending Aorta.

Normal *in vivo* forces associated with heart beats, respiration and patient activity can cause small rotations between the Outflow Graft Bend Relief (A) and the pump. These rotations are expected and appear to be 'back and forth' without accumulation in either direction. However, there is the potential for these forces to be preferentially translated to the outflow graft (B) in either the 'back' or 'forth' direction which may deform the outflow graft and reduce pump flow. The accumulation of outflow graft twist can occur at any point beyond implant. Postoperative twisting and occlusion of the HM3 outflow graft may result in the need for surgical intervention following the original implant procedure.

- During implant, when attaching the Outflow Graft to the Pump Cover, a clicking sound will be heard as the Screw Ring is tightened. Continue turning the Screw Ring clockwise until it comes to a complete stop and stops clicking for a firm hand tightened connection.
- If a low flow alarm persists at any time following implant, and other potential causes such as hypertension, low preload, right-heart failure and inflow occlusion have been considered for cause, a Computed Tomography (CT) angiography should be taken to identify the possibility of an outflow graft twist occlusion.
- In the event surgical repair of the outflow graft is needed due to a twist occlusion, the Outflow Graft Bend Relief should be reattached in its original state or repaired to prevent further kinking or occlusion of the graft.
