IMPORTANT MEDICAL DEVICE ADVISORY

HeartMate 3™ Left Ventricular Assist System Catalog # 106524INT – HM3 LVAS KIT

April 5th, 2018

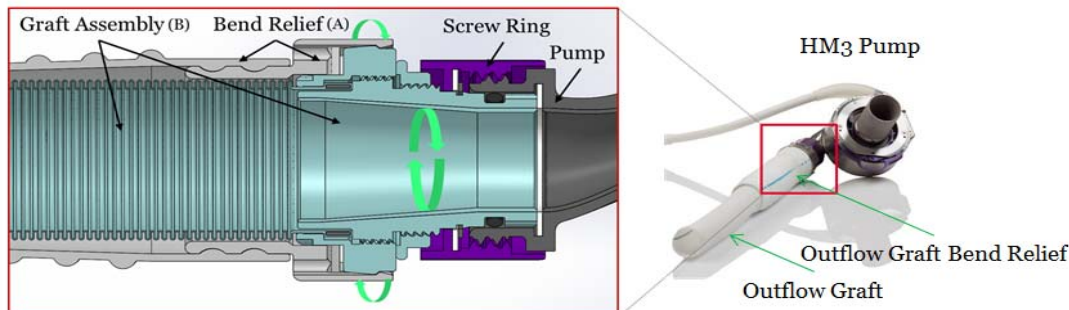
The Outflow Graft is the conduit for blood flow from the HM3 pump to the ascending Aorta.

Normal *in vivo* forces associated with heart beats, respiration and patient activity can cause small rotations between the Outflow Graft Bend Relief (A) and the pump. These rotations are expected and appear to be 'back and forth' without accumulation in either direction. However, there is the potential for these forces to be preferentially translated to the outflow graft (B) in either the 'back' or 'forth' direction which may deform the outflow graft and reduce pump flow. The accumulation of outflow graft twist can occur at any point beyond implant. Postoperative twisting and occlusion of the HM3 outflow graft may result in the need for surgical intervention following the original implant procedure.

- During implant, when attaching the Outflow Graft to the Pump Cover, a clicking sound will be heard as the Screw Ring is tightened. Continue turning the Screw Ring clockwise until it comes to a complete stop and stops clicking for a firm hand tightened connection.
- If a low flow alarm persists at any time following implant, and other potential causes such as hypertension, low preload, right-heart failure and inflow occlusion have been considered for cause, a Computed Tomography (CT) angiography should be taken to identify the possibility of an outflow graft twist occlusion.
- In the event surgical repair of the outflow graft is needed due to a twist occlusion, the Outflow Graft Bend Relief should be reattached in its original state or repaired to prevent further kinking or occlusion of the graft.
