IMPORTANT FIELD SAFETY NOTICE

CentriMag™ Acute Circulatory Support System Motor Model: 201-10002
Compatible with CentriMag™ Pump and PediVas™ Pump

September 5, 2018

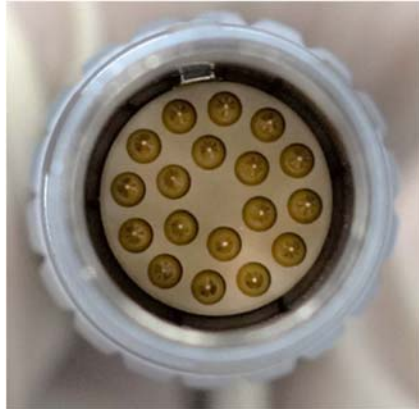
Figure 2: Motor Connector Pin View

- Visual inspection regarding inspection for motor cable damage from the CentriMag Circulatory Support System Operating Manual and supplemental pages (for 1st Generation Consoles)
1. Visually inspect the CentriMag Motor connector for bent or broken pins. Check for burn marks or melted plastic.

Note: If there are any issues while connecting the CentriMag Motor to the CentriMag Console, inspect the Motor port on the rear of the Console for damage, particularly for any broken pins that may be lodged inside.

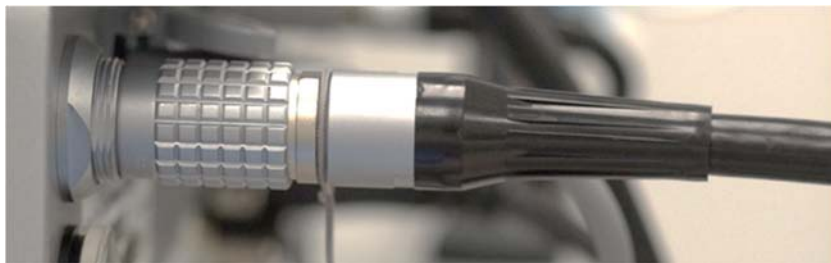
Figure 3: Cable Bend Relief at the Console Connector

2. Visually inspect the entire length of the CentriMag Motor cable, including both bend reliefs (see Figures 3 and 4), for any damage such as separations of the bend reliefs, deformations, kinks, or cuts. These types of damage indicate wear and tear or previous rough handling of the cable, which has the potential to result in internal wire damage. Cable thickness and shape should be uniform throughout the length of the cable.

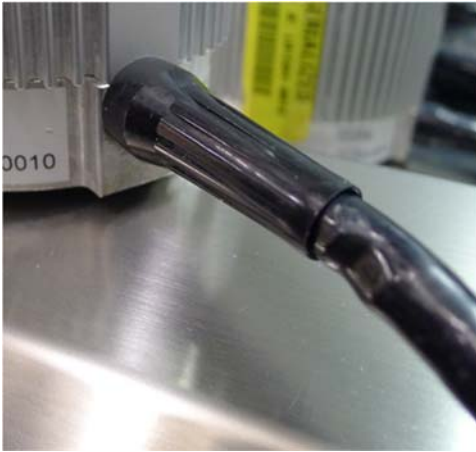
Our analysis of devices associated with the motor stop field complaints showed that the motor stop can be attributed to a break of a wire or short circuit between wires within the electrical cable where the cable exits the motor cable bend protection. This damage may be avoided by ensuring proper handling, such as avoiding tight bending of the cable, or winding the cable around the motor during storage during the life of the motor.

Figure 5: Cable Damage at the Motor Bend Relief

Before each use, verify that the cable connecting the Motor to the Console is not kinked, which can occur with improper handling such as wrapping the cable tightly around the Motor. If the cable is kinked, replace the Motor.

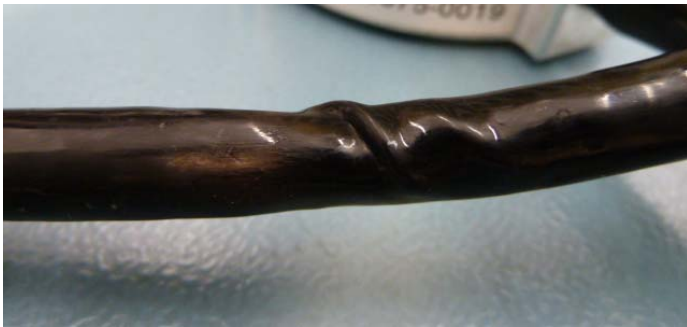
Figure 7: Damaged Motor Cable

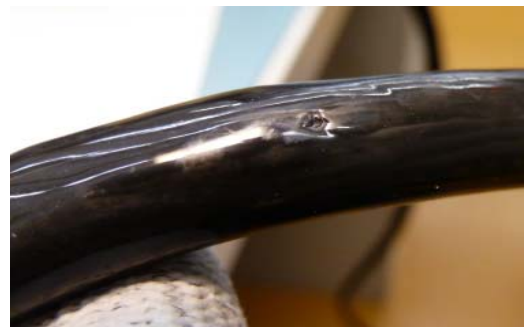
Figure 8: Damaged Motor Cable
