URGENT MEDICAL DEVICE RECALL

HeartMate™ Mobile Power Unit (MPU)
 Used with HeartMate 3™ LVAS and HeartMate II ® LVAS
 (Model Number: 107758UK)

Heart Failure Division
 Abbott Medical
 6305 Stoneridge Dr.
 Pleasanton, CA 94588

March 2025

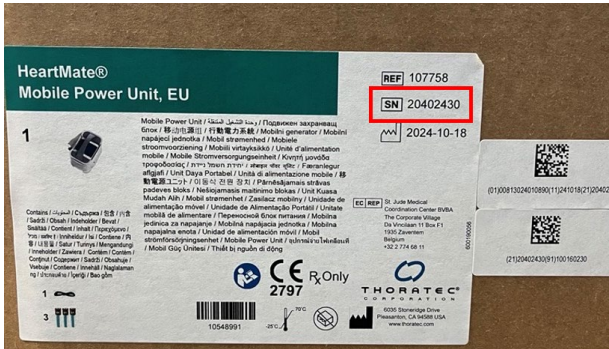
Product Packaging Label

Images of location of MPU Serial Number
