## URGENT MEDICAL DEVICE CORRECTION

FOR A SUBSET OF GALLANT™, NEUTRINO™ NxT,  
AND ENTRANT™ ICDs AND CRT-Ds  
MANUFACTURED PRIOR TO APRIL 2022  
MODELS CDVRA500Q, CDDRA500Q, CDHFA500Q, CDVRA600Q,  
CDDRA600Q, CDHFA600Q, CDVRA300Q, CDDRA300Q, AND CDHFA300Q

August 2023

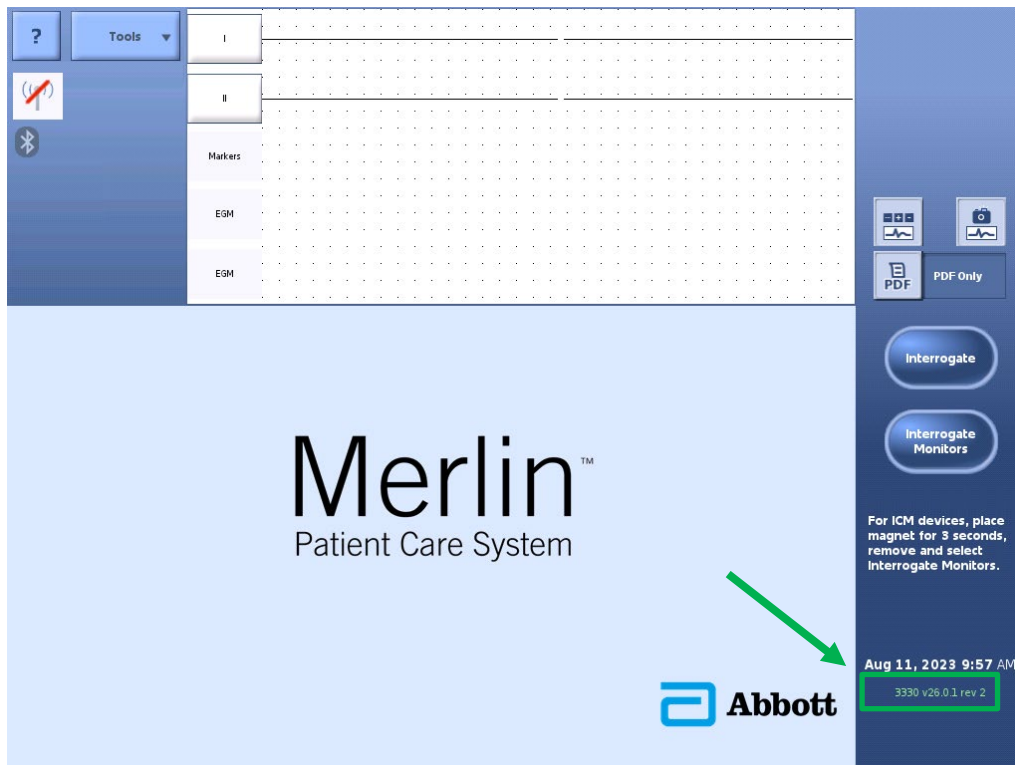
Image 2: Merlin™ PCS 3650 software version visible on the startup screen

The Merlin™ PCS 3650 software version is visible on the lower right corner of the initial startup screen, as displayed in the image below. Confirm the programmer software version is 3330 v25.4.x or higher.
