## URGENT FIELD SAFETY NOTICE

HeartMate II® and HeartMate 3™ System Controllers  
Used with HeartMate 3™ LVAS and HeartMate II® LVAS  
(Model Numbers: 106015, 106762,  
106524INT, 106531INT, 106531LF2)

Heart Failure Division  
Abbott Medical  
6035 Stoneridge Dr.  
Pleasanton, CA 94588

October 2025

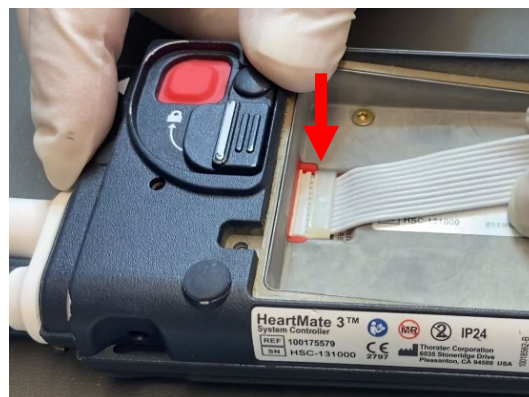
**Figure 1: Connection of Backup Battery Ribbon Cable**

In the confirmed complaints, Abbott identified corrosion at the connection point between the System Controller and the Backup Battery ribbon cable. This can be caused by excessive handling and movement of the ribbon during Backup Battery installation or replacement, specifically at the ribbon cable connection interface, see Figure 1.

To reduce future instances of the Backup Battery Fault Alarm, Abbott is advising that when performing Backup Battery installation or replacement, clinicians should minimize excessive handling, movement, stress and pulling at the interface between the ribbon cable and controller. An example of excessive handling would be using the ribbon cable to hold the weight of the controller.

Abbott is developing and qualifying a change in the System Controller Backup Battery connection interface to address this issue, which will be implemented upon receiving regulatory approvals.
