URGENT FIELD SAFETY NOTICE

HeartMate 3™ LVAS Implant Kit (Model: 106524INT)
HeartMate 3™ System Controller (Model: 106531INT)
HeartMate 3™ System Controller Low Flow 2.0 (Model: 106531LF2)

July 2024

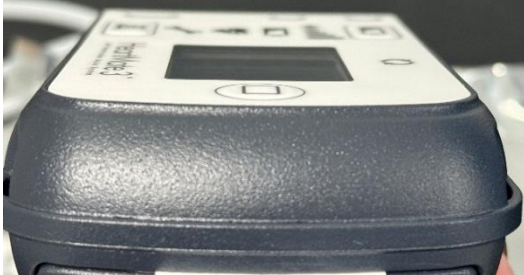
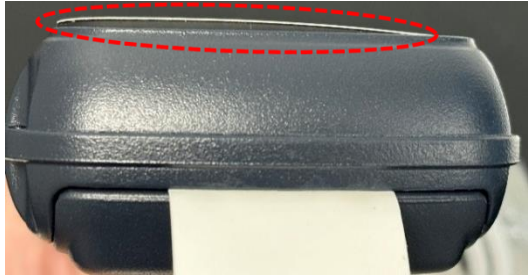
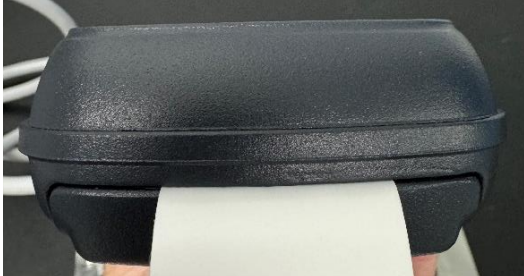
Abbott has identified that there is a potential for the controllers to have a lifted User Interface (UI) membrane that when present, is observed along the edge of the controller housing, near the Display Button as highlighted in images below. The product is not being removed from the field. As of July 8, Abbott has received 4 complaints where a lifted UI membrane was observed by customer with no patient harm reported. It is unlikely that any serious adverse health consequences would occur as a result of the lifted User Interface membrane as detailed below.

If the UI membrane is lifted and if the controller were to be exposed to fluid, there is a potential for fluid ingress into the controller which may lead to damaged Printed Circuit Board Assemblies (PCBA). This could result in unexpected and false positive alarms, as well as loss of the user interface (use of buttons, loss of visual alarms, etc.). Fluid ingress may also lead to loss of power to the pump resulting in a pump stop, however this possibility is very rare due to redundancies in the power path to the pump.

HeartMate 3 System Controller with <u>Lift</u> near the Display Button	HeartMate 3 System Controller with <u>no Lift</u> near the Display Button
Top Edge (close to Display button) View

- Carefully inspect the controller at the edge near the Display Button to confirm that the UI membrane is not lifted (refer to provided visual examples) prior to using the controller or providing the controller to your patient. Do not provide controllers with lifted UI membrane to your patients and report controllers with lifted UI membrane by contacting your local Abbott Representative. Note that controllers that do not present a lifting UI membrane will not lift over time.

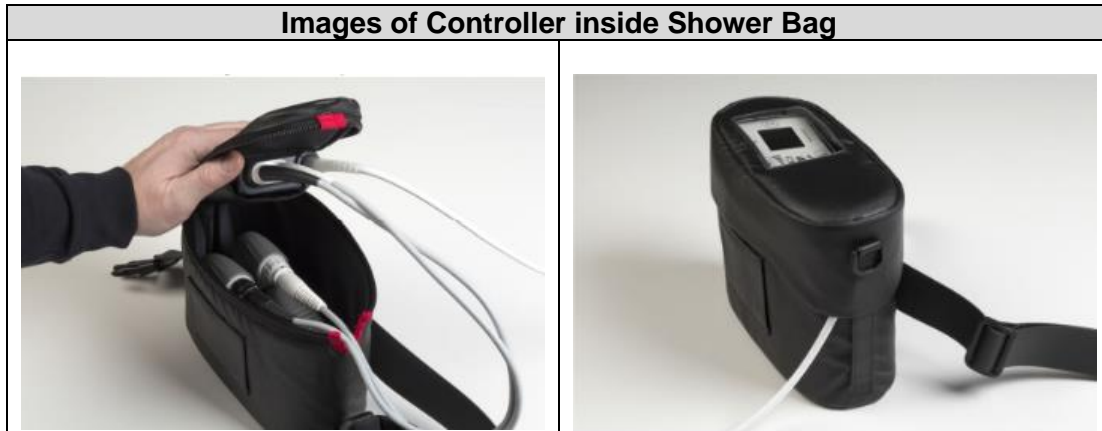
Appendix A – Image of Shower Bag

Refer to IFU pages 6-21 – 6-29 and PHB pages 4-12 – 4-21 on how to use the Shower Bag and the image below of the Controller stored within the Shower Bag.

- Reinforce “General Warning” and “Warnings and Cautions” within the IFU and the PHB to protect the controller from exposure to fluids and keep it dry at all times. In addition, patients who are permitted to shower by a doctor, must use the Shower Bag for every shower. The Shower Bag protects the external system components from water and moisture. Refer to Appendix A for images of Shower Bag.
