## URGENT MEDICAL DEVICE CORRECTION

CentriMag™ Acute Circulatory Support System Motor Model: 102956  
*Compatible with CentriMag™ Pump and PediMag™ Pump*

September 5, 2018

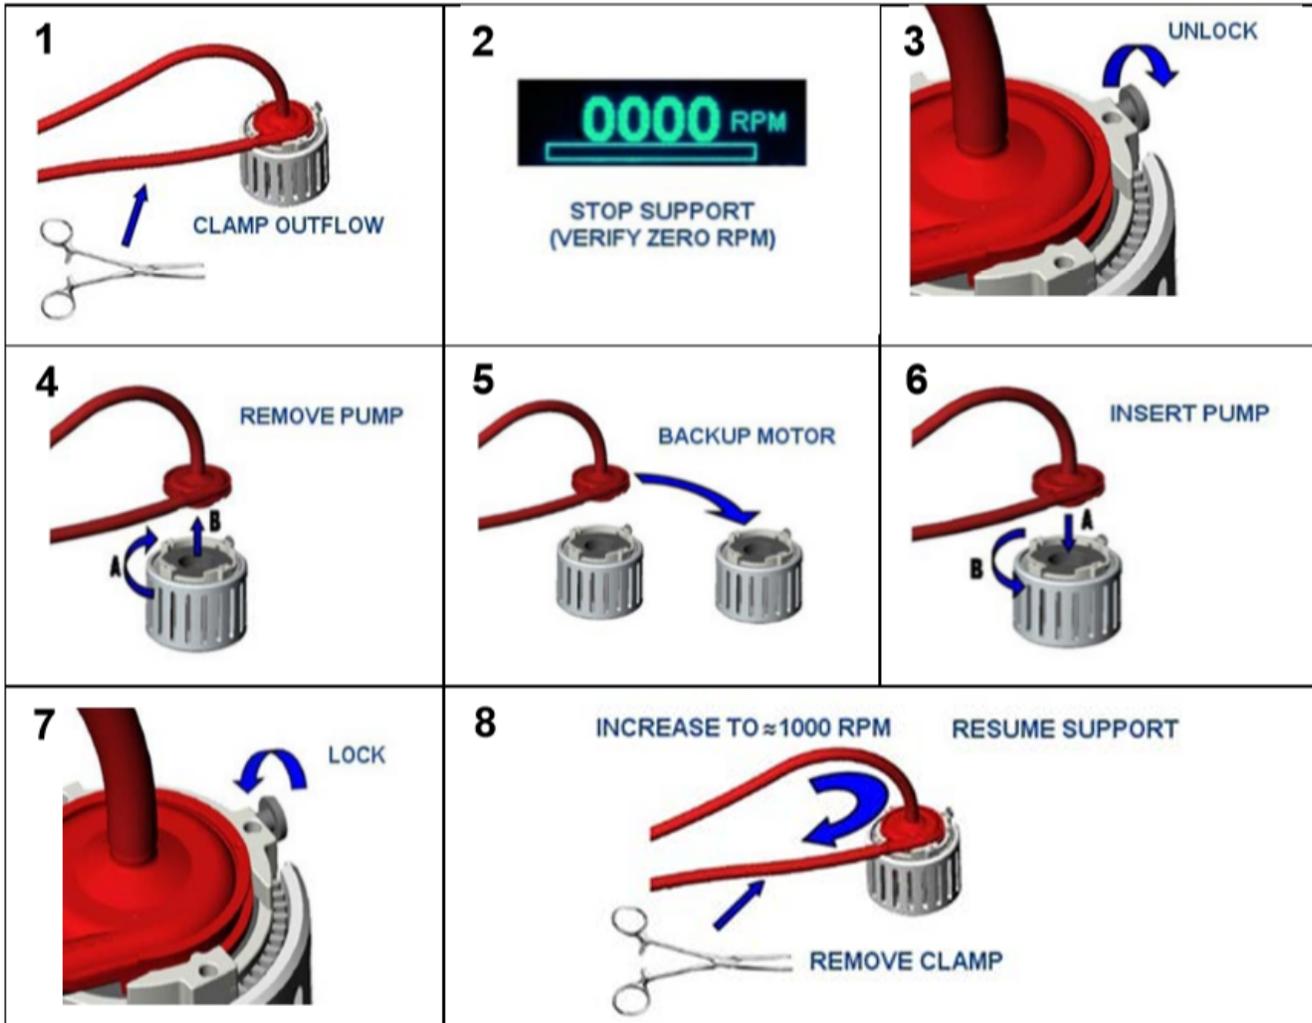
## **Appendix 2: Blood Pump Exchange Instructions**

- Graphic regarding cable handling in the relevant CentriMag Circulatory Support System Operating Manual demonstrating the proper steps from transitioning a pump between the primary and backup systems.

- A full backup system must be in the immediate vicinity of every patient supported by the CentriMag System.
- Exchange the pump to the backup system as described in the CentriMag System Operating Manual and in Appendix 2. Improperly exchanging only the motor to a backup console could cause damage or harm.

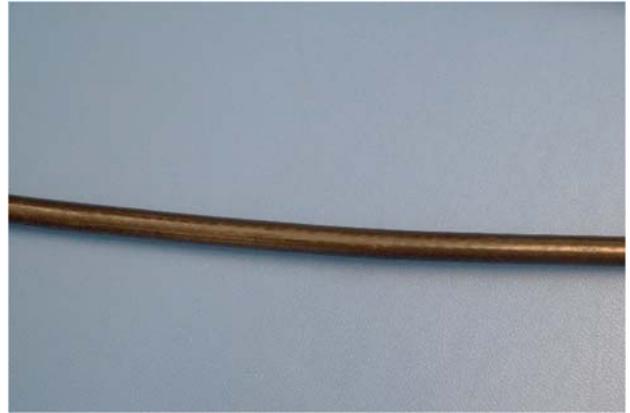
**Figure 6: Undamaged and Intact Motor Cable**

2. Visually inspect the entire length of the CentriMag Motor cable, including both bend reliefs (see Figures 3 and 4), for any damage such as separations of the bend reliefs, deformations, kinks, or cuts. These types of damage indicate wear and tear or previous rough handling of the cable, which has the potential to result in internal wire damage. Cable thickness and shape should be uniform throughout the length of the cable.

- Inspection of the CentriMag Motor, including the cable, for damage should be conducted prior to use. Do not use if damaged. If the cable is damaged and not visible as part of the inspection, the console will alarm during the procedure. Further detail about the visual inspection can be found in Appendix 3.
