Safety Alert
HeartMate Touch™ Communication System
(Model: HMT1150)
GTIN: 05415067032041
(WAND: 210119-WAND-6W5ZY5)

Medsafe Reference: 31591

August 2023

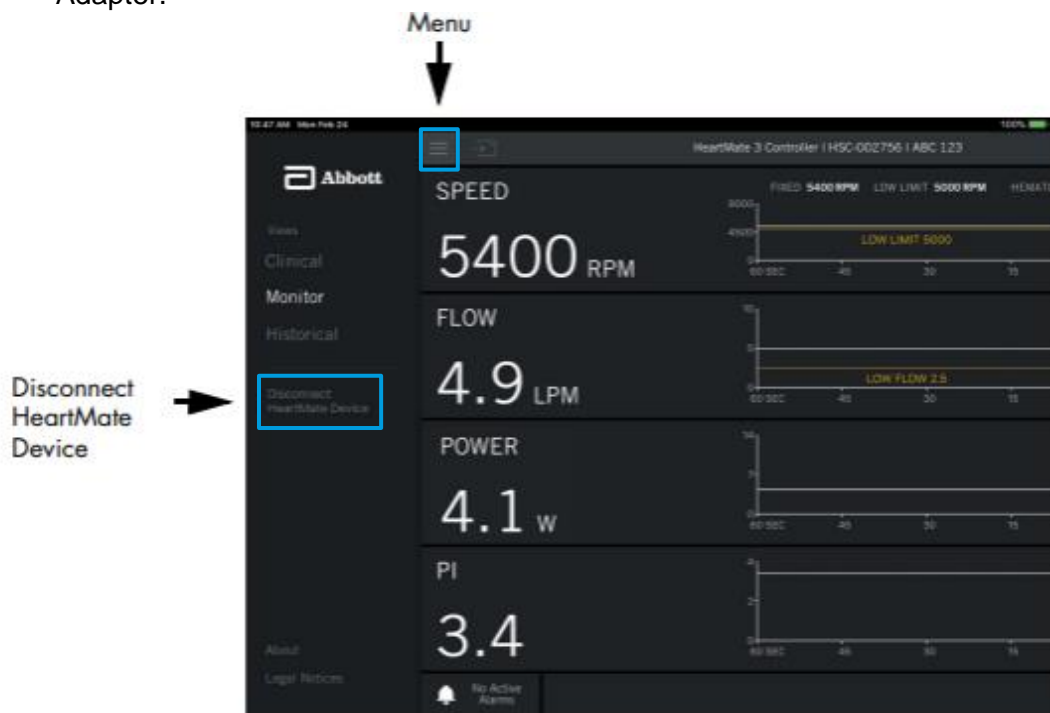
- Tap Menu -> Disconnect HeartMate Device. A confirmation message appears asking you to confirm.
- Tap Yes to disconnect the HeartMate Touch App from the HeartMate Touch Wireless Adapter.

In the event the HeartMate Touch is connected to an unintended LVAS, follow the existing Instructions For Use to disconnect the HeartMate Touch App from the HeartMate Touch Wireless Adapter by:

- Make sure to disconnect the HeartMate Touch Wireless Adapter from the Power Module before proceeding with re-establishing a connection per the Instructions For Use.
