HeartMate II® and HeartMate 3™ System Controllers  
Used with HeartMate 3™ LVAS and HeartMate II® LVAS  
Model Numbers: 106524INT (ARTG 468565); 106531INT (ARTG 289763); 106531LF2  
(ARTG 345788); 106016 (ARTG 226356 - discontinued); 106017 (ARTG 292290)

16 October 2025

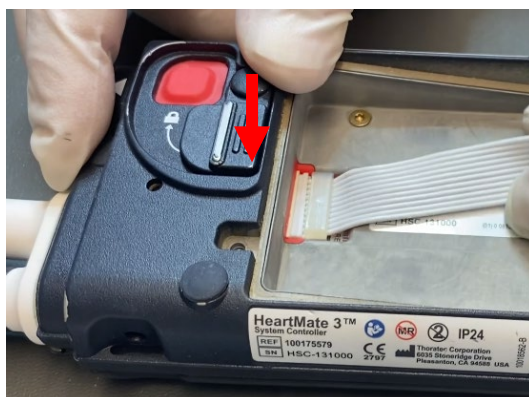
**Figure 1: Connection of Backup Battery Ribbon Cable**

In the confirmed complaints, Abbott identified corrosion at the connection point between the System Controller and the Backup Battery ribbon cable. This can be caused by excessive handling and movement of the ribbon during Backup Battery installation or replacement, specifically at the ribbon cable connection interface, see Figure 1.

The majority of the reports received by Abbott included anxiety, inconvenience or a replacement of the back-up battery or controller. The Kaplan Meier estimate of the rate of Backup Battery Fault Alarms that may be related to corrosion is

1.6% at 1 year, 3.2% at 2 years and 4.1% at 3 years. Between August 2020 and May 2025, there is an overall complaint rate of 5.26% for Backup Battery Fault Alarms irrespective of system controller age. A complaint rate of 0.03% was associated with patients attempting to exchange their controller without clinical support, which contributed to adverse patient outcomes, including hemodynamic compromise and death.

To reduce future instances of the Backup Battery Fault Alarm, Abbott is advising that when performing Backup Battery installation or replacement, clinicians should minimise excessive handling, movement, stress and pulling at the interface between the ribbon cable and controller. An example of excessive handling would be using the ribbon cable to hold the weight of the controller.

Abbott is developing and qualifying a change in the System Controller Backup Battery connection interface to address this problem, which will be implemented upon receiving regulatory approvals.
