Urgent Medical Device Correction

HeartMate Touch™ Communication System
(Models: HMT1150)
GTIN:05415067032058

July 2023

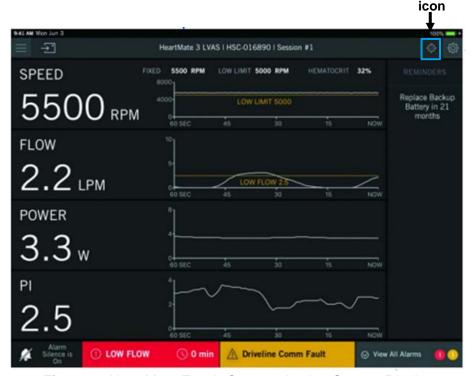
Figure 1: HeartMate Touch Communication System Display

Use the 'Locate' feature to identify the Adapter to which the system is connected. To do this:

Tap on the 'Locate' icon on the top right corner of the HeartMate Touch
 Communication System display.

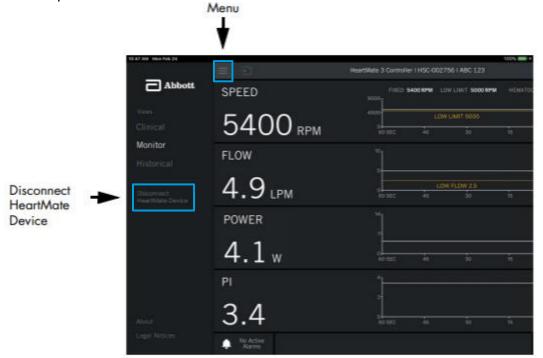
In the event the HeartMate Touch is connected to an unintended LVAS, follow the existing Instructions For Use to disconnect the HeartMate Touch App from the HeartMate Touch Wireless Adapter by:

Tap Menu -> Disconnect HeartMate Device. A confirmation message appears asking you to confirm. Tap Yes to disconnect the HeartMate Touch App from the HeartMate Touch Wireless Adapter.

Make sure to disconnect the HeartMate Touch Wireless Adapter from the Power Module before proceeding with re-establishing a connection per the Instructions For Use.
