Urgent Medical Device Correction System Monitor

**Model Numbers: 1286, L1286, 1286A, 1286A-CAN,
L1286A,1286A-US, L1286A-US, 1286C, L1286C, 1286INT, L1286INT,**

Heart Failure Division
Abbott Medical
6035 Stoneridge Drive
Pleasanton, CA 94588

May 2024

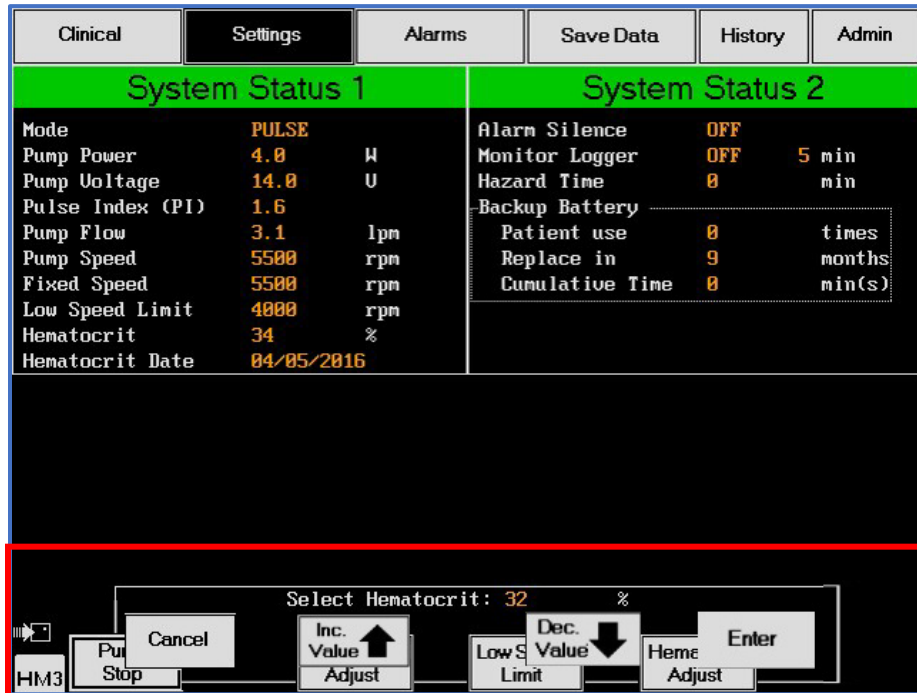
See Appendix A for illustrations of an atypical screen behavior of the “Cancel Button” overlapping the “Pump Stop” button (Figure 1) and an example of the expected screen appearance (Figure 2).

Figure 1 – Example of Atypical Screen Behavior, Overlapping Buttons

Abbott is advising clinicians to restart the System Monitor unit before connecting to the Controller, if the unit has been running for a long period of time, or if screen issues are observed. To restart the unit, turn off and then turn on using the On/Off Switch located on the back of the System Monitor. It takes approximately 10 seconds to fully restart and display the information on the screen. See Appendix B, Figure 3 for a view of the back of the System Monitor illustrating where to locate the On/Off Switch (circled in red). If the unit is restarted while connected to the patient's Controller the LVAD settings will remain the same.

Upon System Monitor restart, if the screen display issues continue, check that all cables and connections are secure and undamaged. If the atypical screen issues persist, use a different System Monitor.
