# Urgent Medical Device Correction

## System Monitor

### Model Numbers: 1286 and 1286INT

May 2024

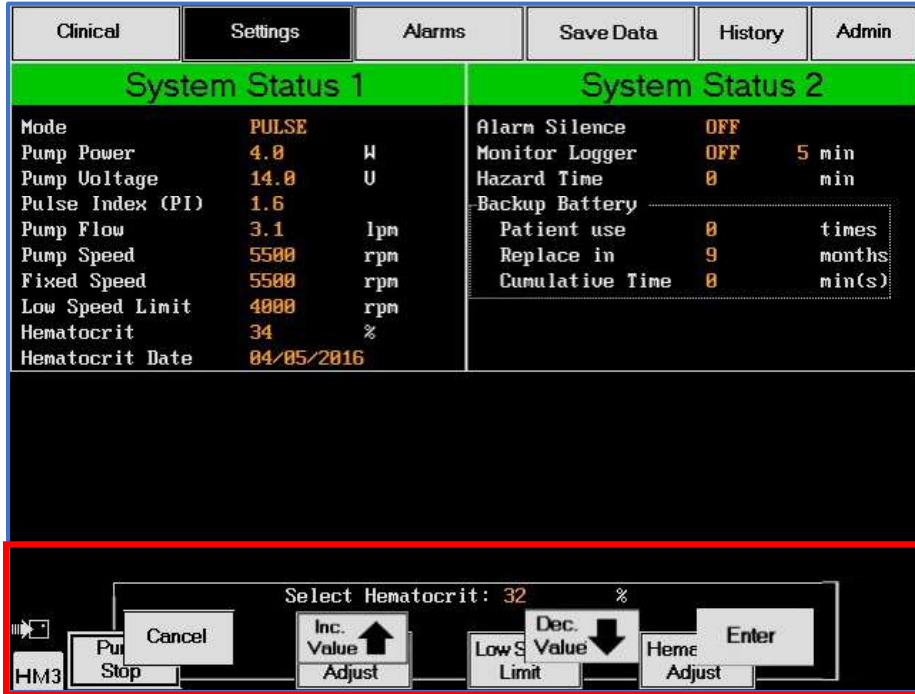
Abbott has received customer complaints for the System Monitor due to atypical screen display behaviors. All System Monitors can potentially show atypical screen display behaviors. Restarting the System Monitor should resolve these issues in most cases. There have not been any serious adverse health consequences associated with these complaints.

- Overlapping screens/buttons
- Frozen screen
- Distorted text, blanks, or zeroes in place of values
- Unresponsive buttons where the user is unable to initiate a command.

See Appendix A for illustrations of an atypical screen behavior of the “Cancel Button” overlapping the “Pump Stop” button (Figure 1) and an example of the expected screen appearance (Figure 2).

Figure 1 – Example of Atypical Screen Behavior, Overlapping Buttons

Abbott is advising clinicians to restart the System Monitor unit before connecting to the Controller, if the unit has been running for a long period of time, or if screen issues are observed. To restart the unit, turn off and then turn on using the On/Off Switch located on the back of the System Monitor. It takes approximately 10 seconds to fully restart and display the information on the screen. See Appendix B, Figure 3 for a view of the back of the System Monitor illustrating where to locate the On/Off Switch (circled in red). If the unit is restarted while connected to the patient's Controller the LVAD settings will remain the same.

Upon System Monitor restart, if the screen display issues continue, check that all cables and connections are secure and undamaged. If the atypical screen issues persist, use a different System Monitor.

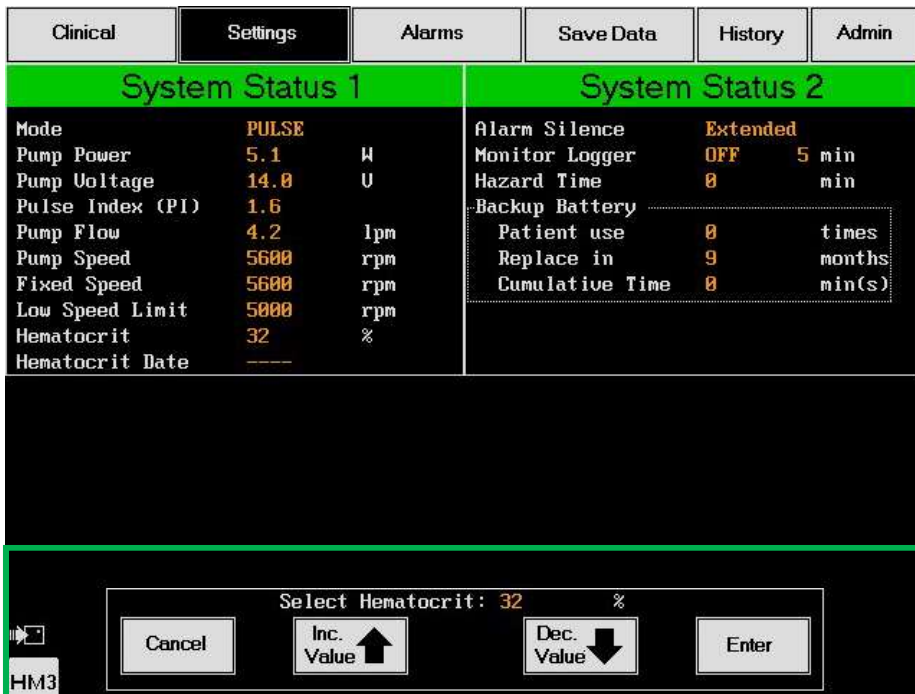
Figure 2 – Example of Expected Appearance of the Screen
